March 17, 2025

Re: TCCS Solar Carports Project – Tree Study - 101 S. Mills Avenue, Claremont, CA

Exhibit A - TreeWorks® Aerial with Tree Study Points for the Solar Carports Project Area – TCSC – 101 S. Mills Avenue, Claremont
Carlberg Associates

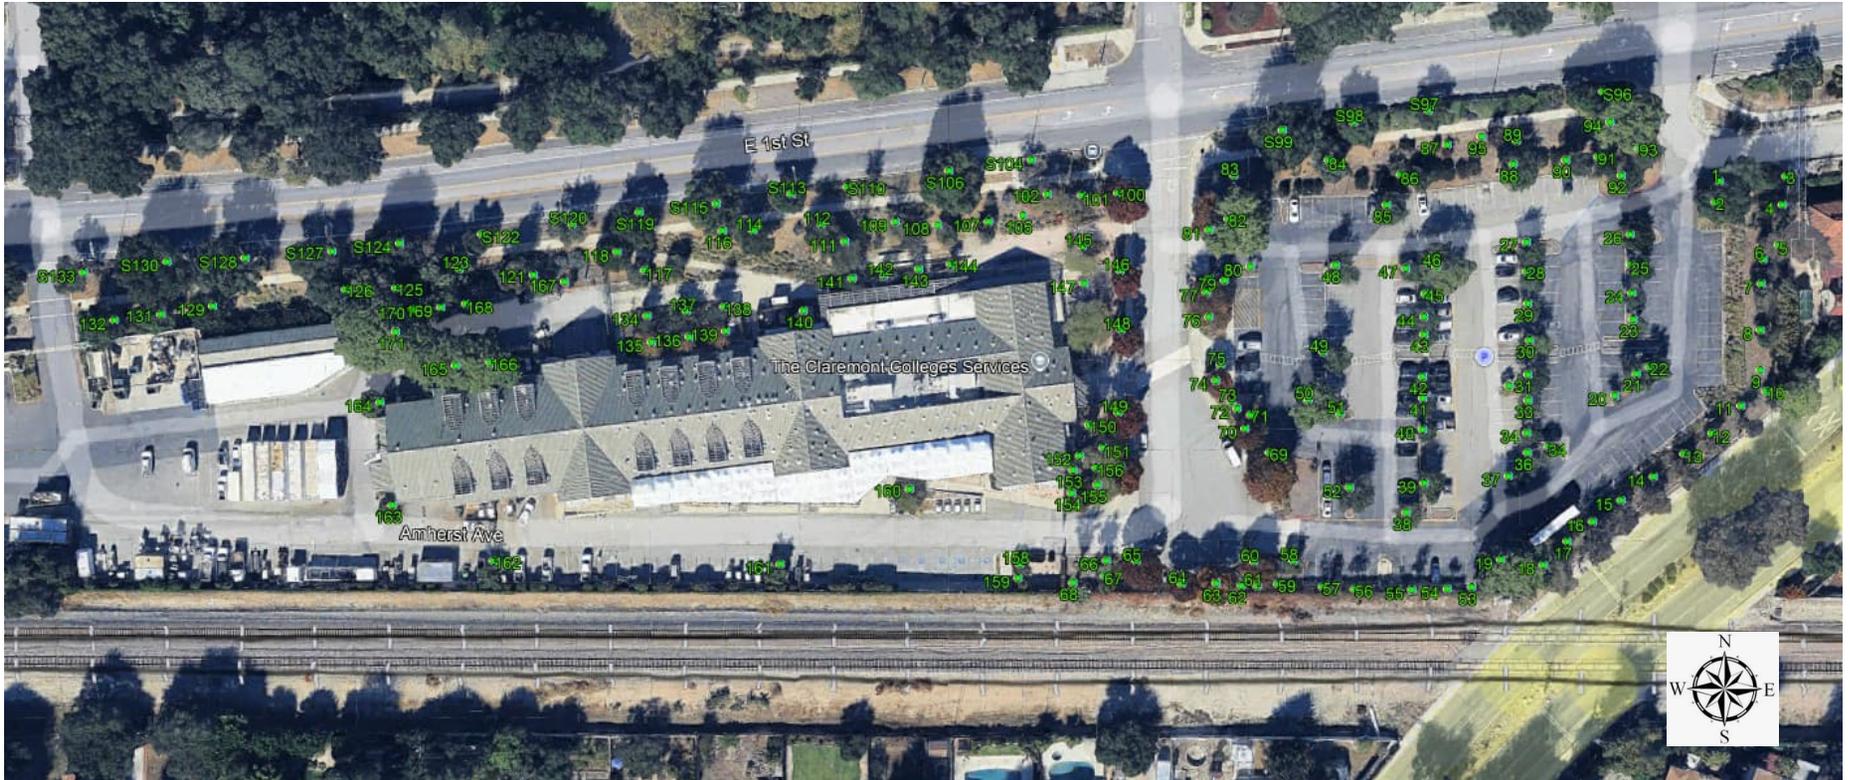
- The majority of the trees in the direct impact areas are in good to very good condition for their age class.
- The spacing of the trees roughly 20-feet apart is a bit close for coast live oaks, but it does not reach the threshold where I would recommend any removals due to overcrowding.
- There will be 32 tree removals due to array placement – these include
 - direct removals due to panel placement
 - they are too close to the panels and will need severe canopy pruning, and/or
 - they will significantly shade the panels when they reach maturity

- There are 24 trees adjacent to the work areas that should be protected during construction to ensure that their root zones and canopies are not significantly impacted by trenching for the new conduit lines or by construction-related equipment.
- There are 115 tree sites that are outside of the direct or immediately adjacent work areas
 - 3 of these sites are now empty

- Tree #S104, outside of the impact area, is recommended for removal and replacement regardless of the project due to a significant decline in health.
- Of the 32 removal trees, Trees #20 and #40 are recommended for removal and replacement regardless of the project due to structural defects.
