425 W 10th

Mill's Act Photo Survey

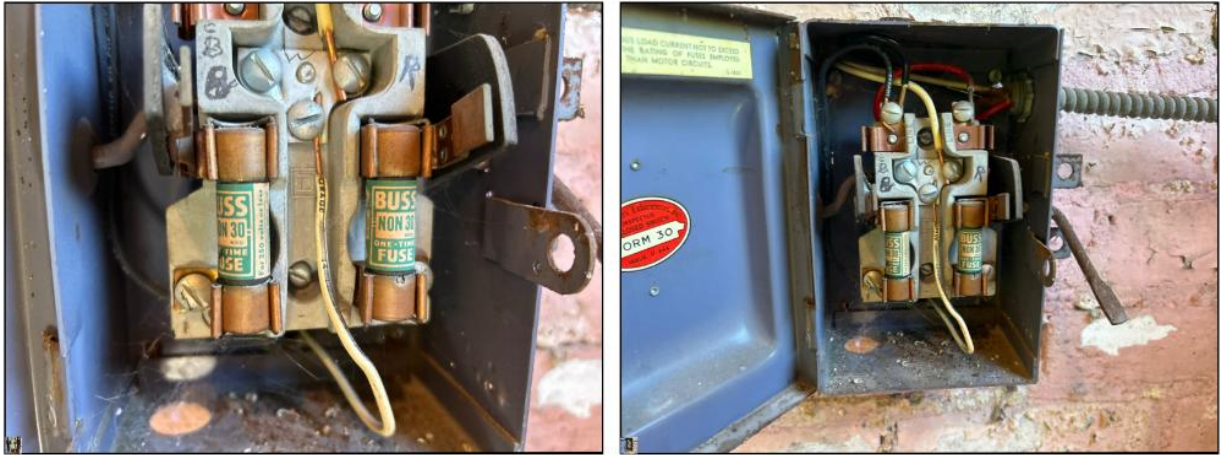
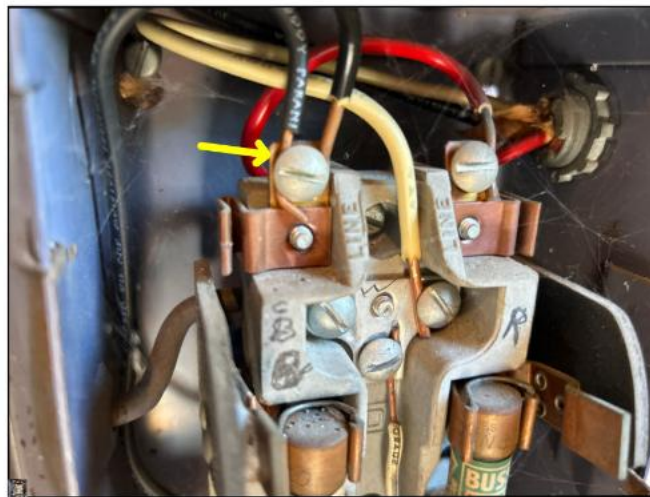
Double tapped/lugged breakers present are a sign of an overloaded panel – recommend licensed electrician for evaluation. At detached garage.

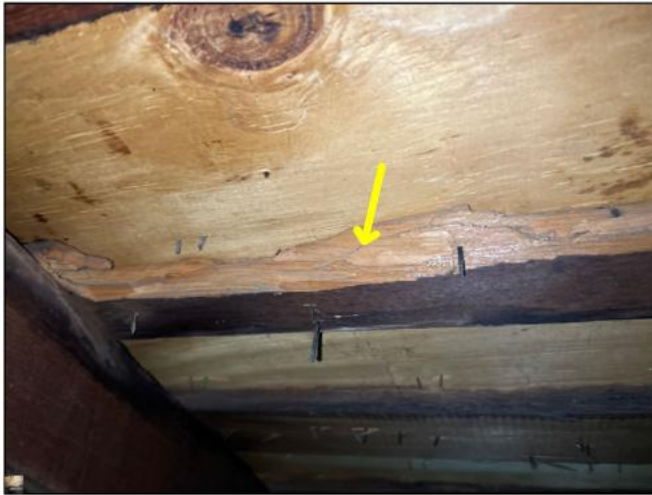
**Deteriorated wood observed -
consult termite report**

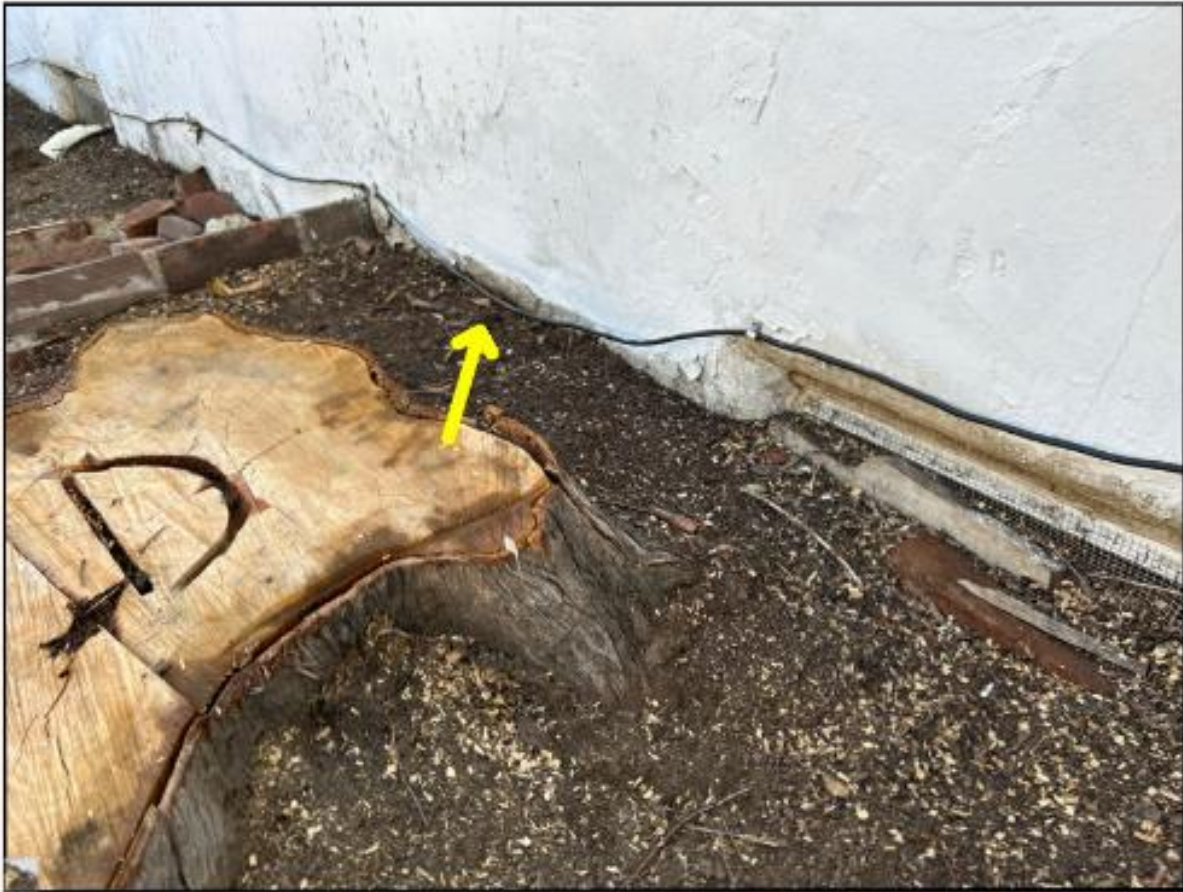
**Soil is high on house exterior wall
in planter areas may allow
moisture intrusion - recommend
servicing**

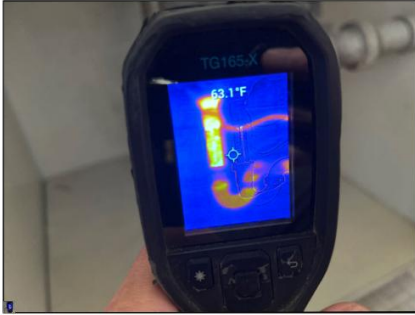
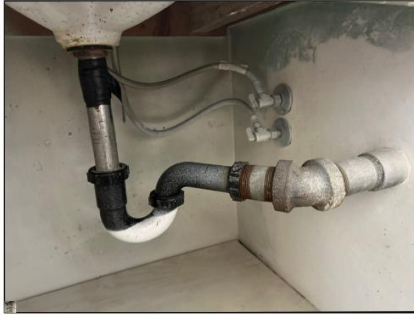
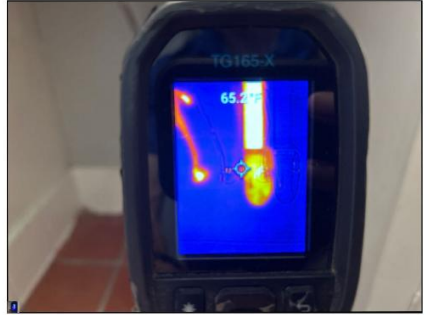
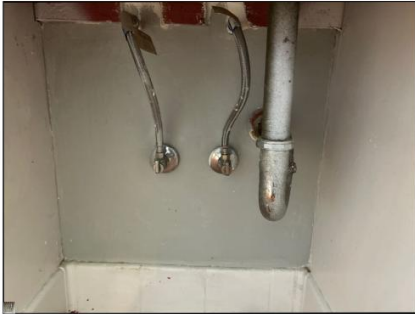
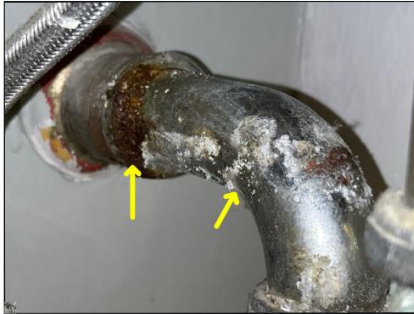
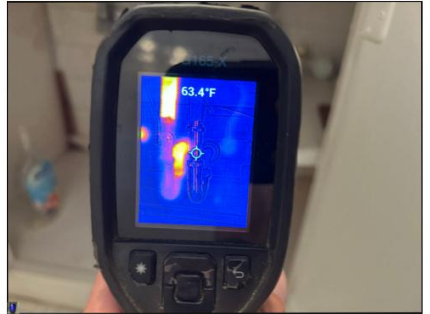
Corrosion is present at plumbing areas - this is a sign of slow leaking and should be further evaluated by a plumber. Master bathroom.

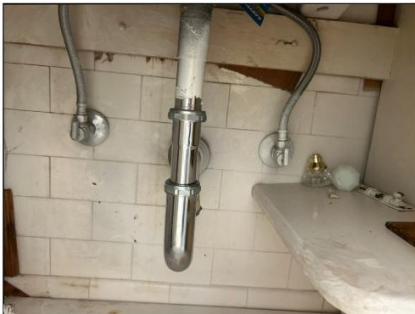
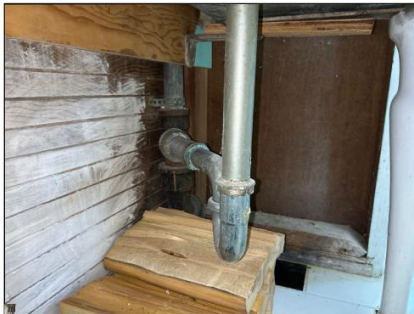
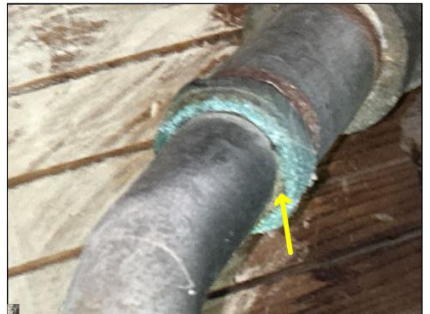
Corrosion is present at plumbing areas - this is a sign of slow leaking and should be further evaluated by a plumber. Half bathroom.

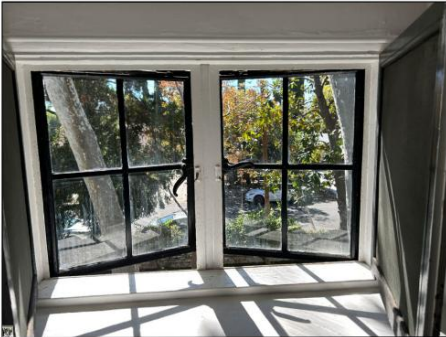
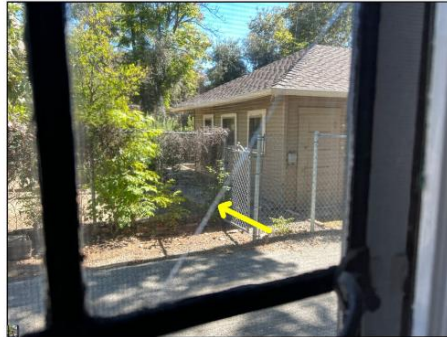
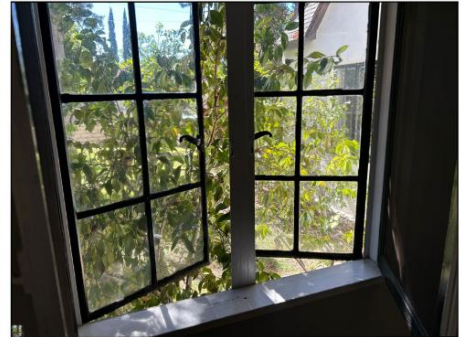
Cracked glass- needs to be serviced. Studio.

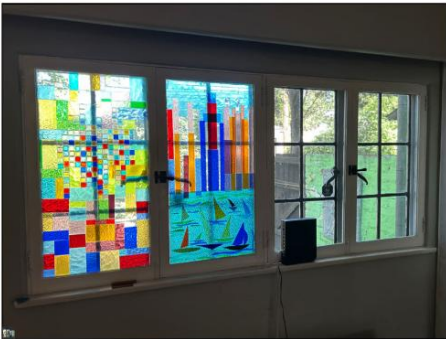
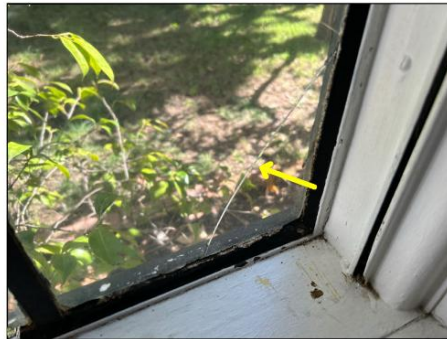
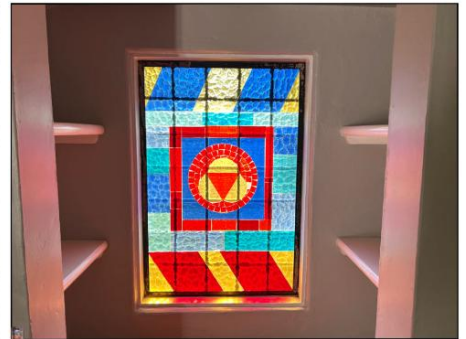
Cracked glass- needs to be serviced. Stairs bedroom.

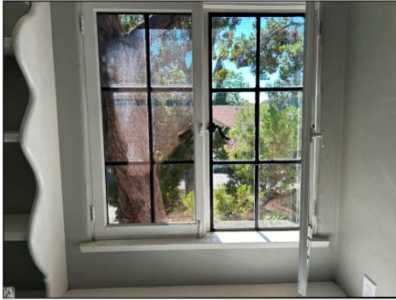
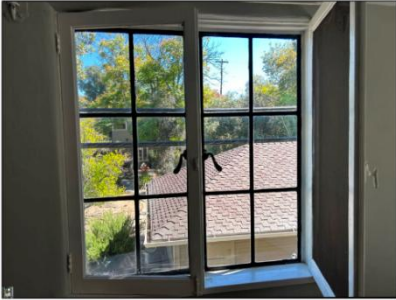
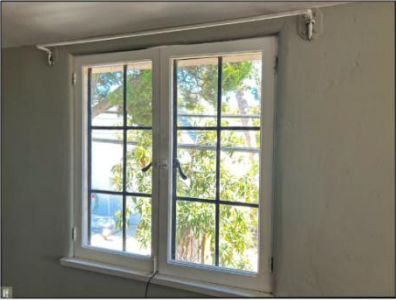
Cracked glass- needs to be serviced. Master bathroom.

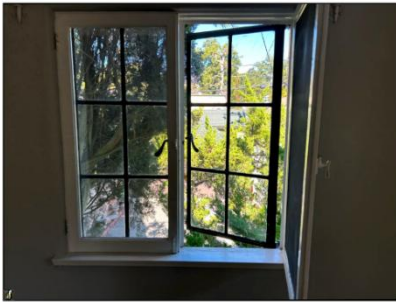
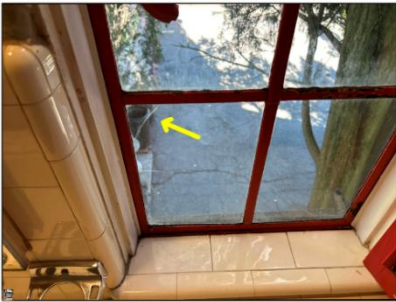
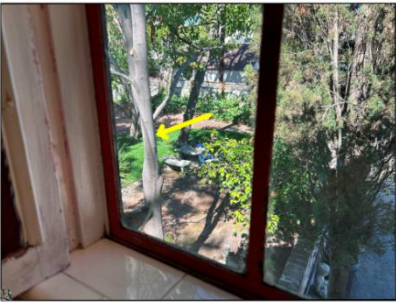
Cracked glass- needs to be serviced. Master bathroom.

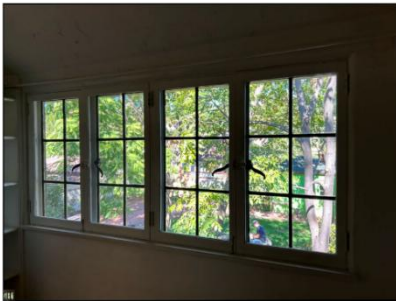
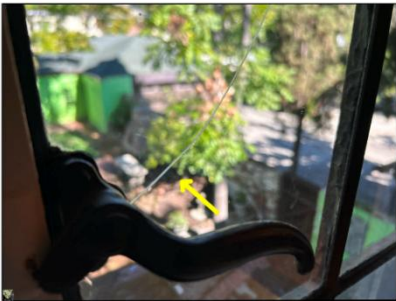
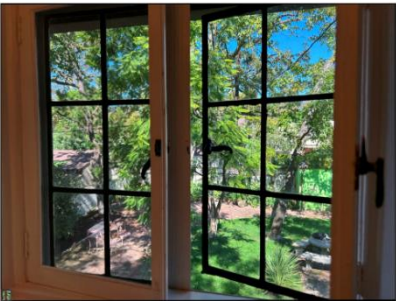
Cracked glass- needs to be serviced. Upstairs, Jack and Jill bathroom

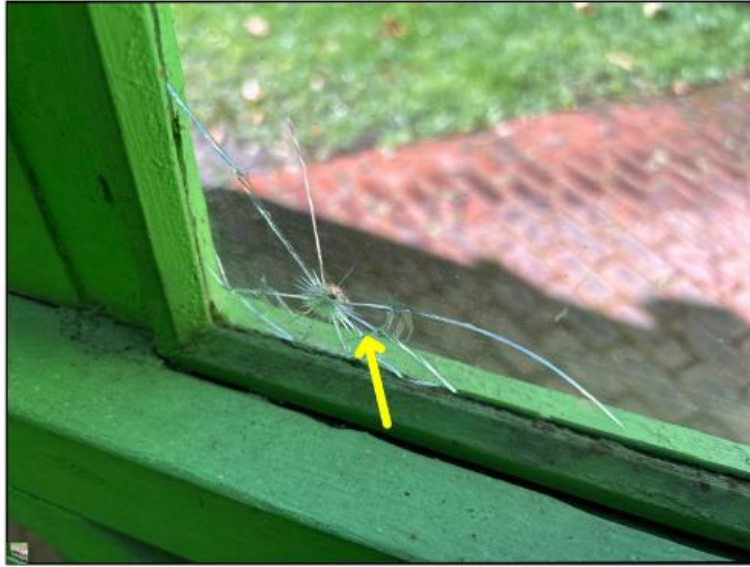
Cracked glass - needs to be serviced

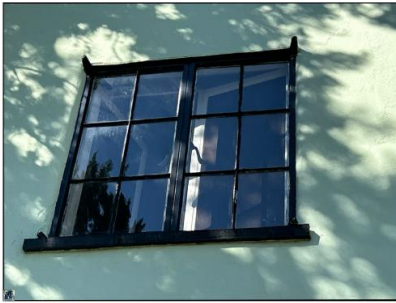
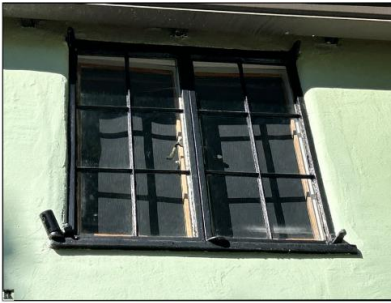
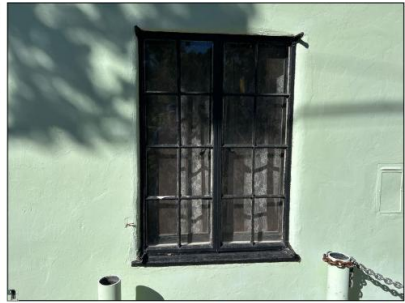
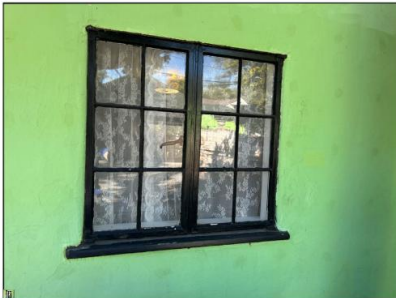
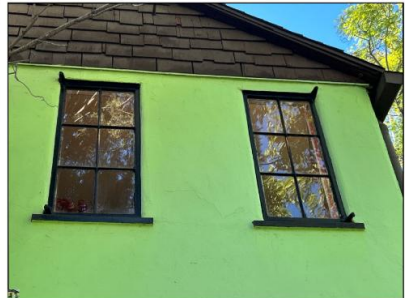
Cracked glass - needs to be serviced

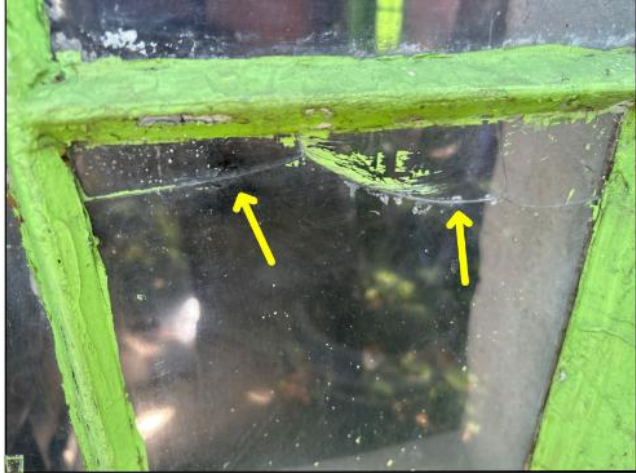
Cracked glass - needs to be serviced. At detached garage.
