October 23, 2025

**Re: Tree Inventory and Impact Report – Amendment Letter, Revised 10.23.25  
Roberts East Campus Sports Bowl, Claremont McKenna College, Claremont, California**

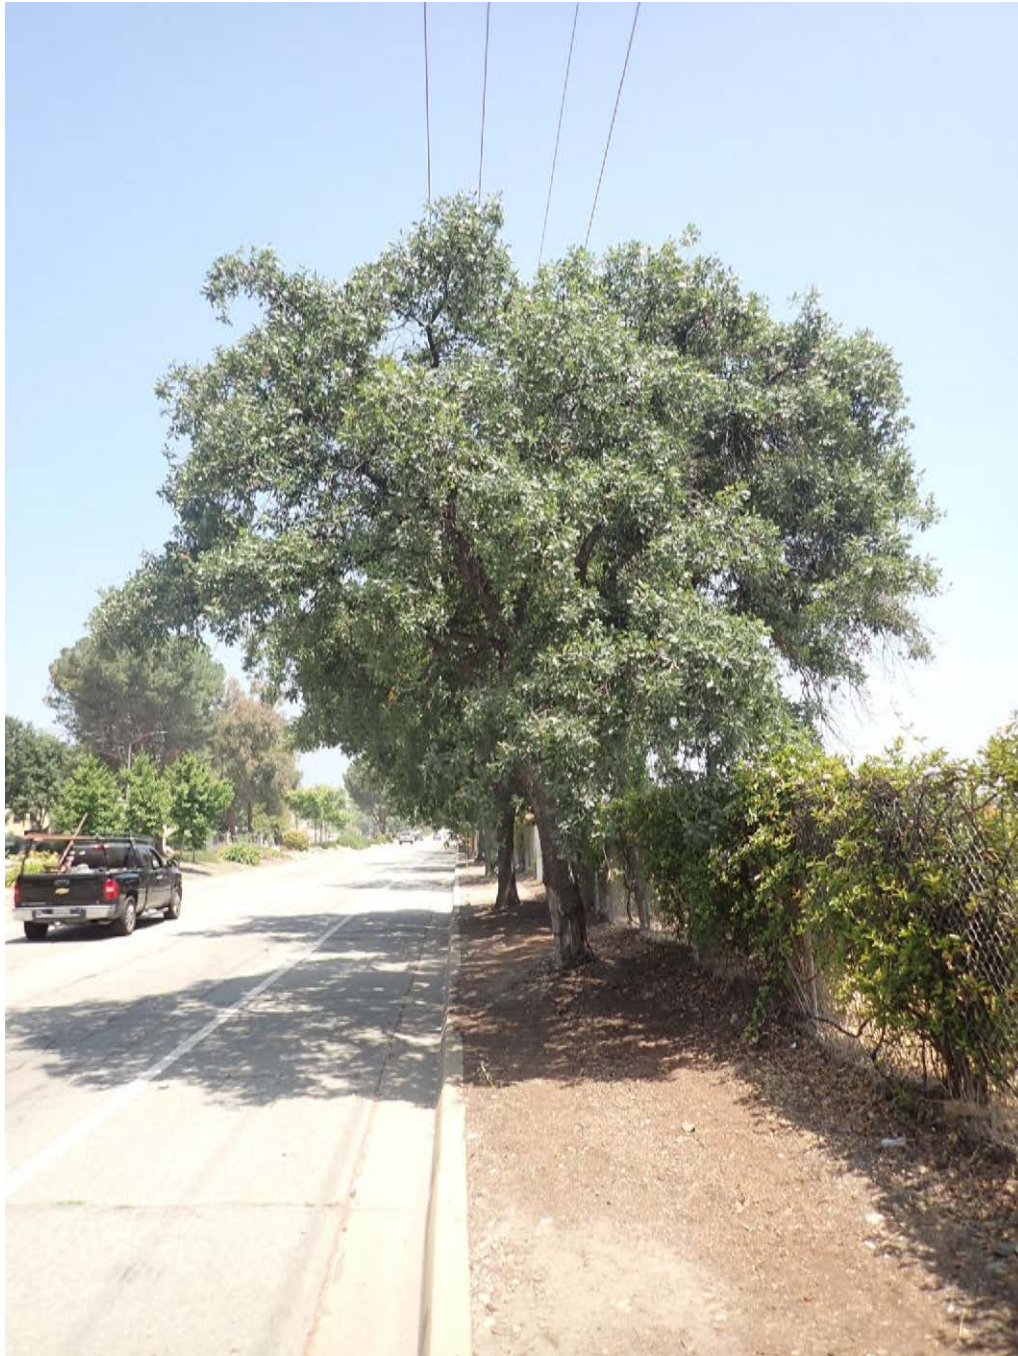
- Tree ST3
- *Quercus lobata*
- Arborist's opinion - Planted
- Facing north

| Street Tree (ST)/Private Property Tree (PP) | Tree ID # | Common Name | Botanical Name | DBH (in.) | CRZ 3' (Ft.) | CRZ 5' (Ft.) | Height (Ft.) | Canopy N (Ft.) | Canopy E (Ft.) | Canopy S (Ft.) | Canopy W (Ft.) | Health Grade | Structure Grade | ST Tree Trunk (center) Distance to Curb Face (in inches) | Tree Disposition (Preserve or Remove) | Comments |
|---|---|---|---|---|---|---|---|---|---|---|---|---|---|---|---|---|
| ST | 3 | valley oak | <i>Quercus lobata</i> | 14 | 3.5 | 5.8 | 25 | 16 | 18 | 18 | 16 | B | B- | 58 | Preserve | pruned for clearance, MPE, large cavity on SW, likely hit by car, mechanical damage, excellent callous |

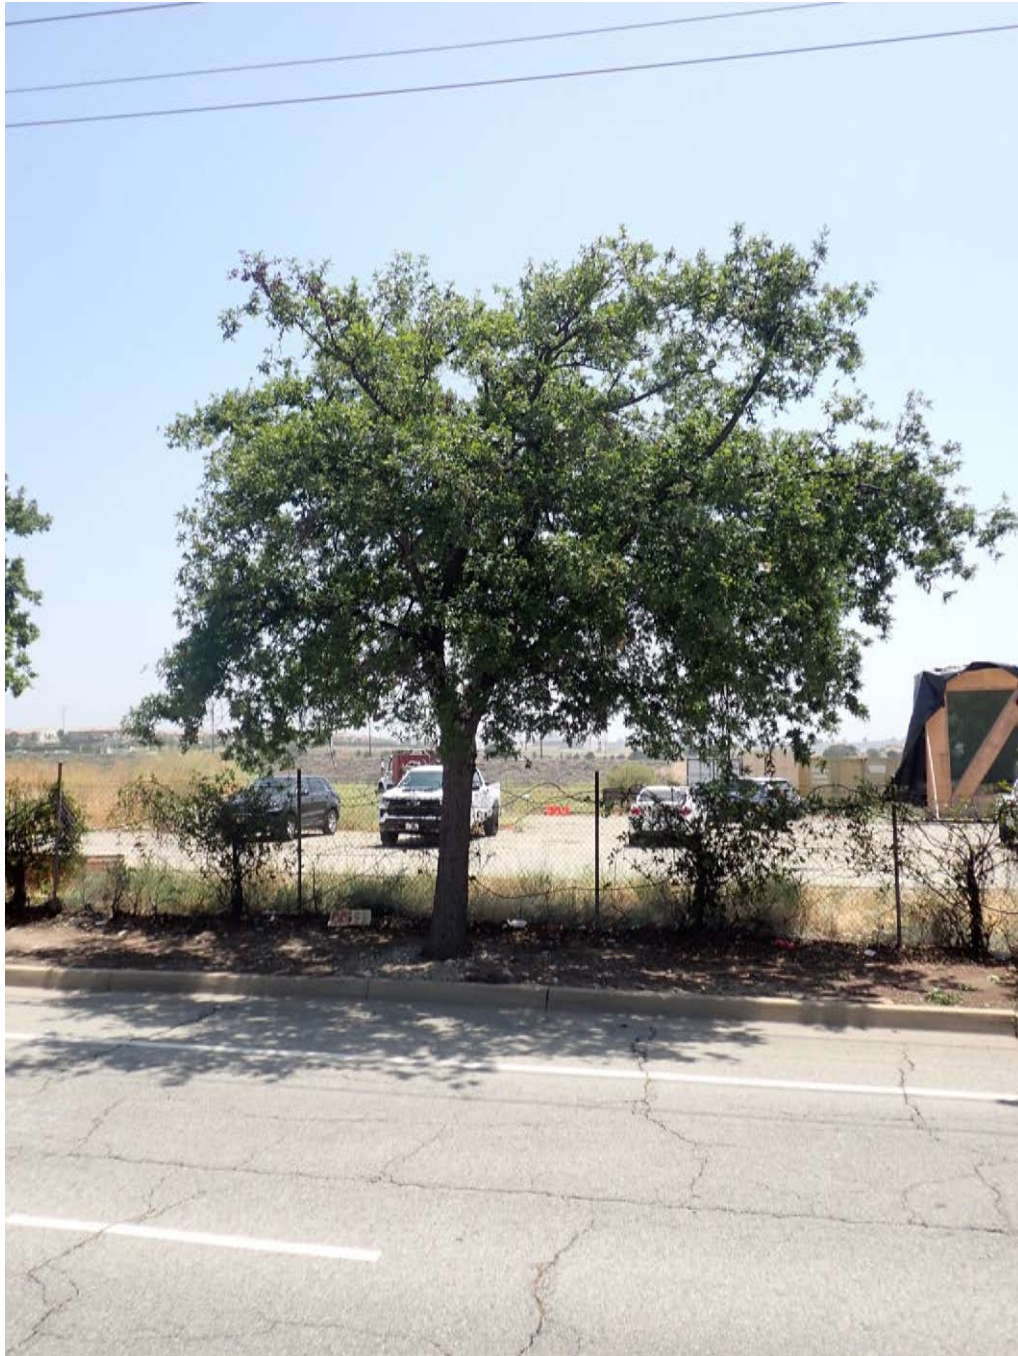
- Tree ST11
- *Quercus lobata*
- Arborist's opinion - Planted
- Facing east

| Street Tree<br>(ST)/Private<br>Property<br>Tree (PP) | Tree ID<br># | Common<br>Name | Botanical<br>Name | DBH<br>(in.) | CRZ 3'<br>(Ft.) | CRZ 5'<br>(Ft.) | Height<br>(Ft.) | Canopy N<br>(Ft.) | Canopy E<br>(Ft.) | Canopy S<br>(Ft.) | Canopy W<br>(Ft.) | Health<br>Grade | Structure<br>Grade | ST Tree<br>Trunk<br>(center)<br>Distance<br>to Curb<br>Face (in<br>inches) | Tree<br>Disposition<br>(Preserve<br>or<br>Remove) | Comments |
|---|---|---|---|---|---|---|---|---|---|---|---|---|---|---|---|---|
| ST | 11 | valley oak | <i>Quercus lobata</i> | 13.9 | 3.5 | 5.8 | 24 | 15 | 24 | 22 | 10 | B+ | B- | 42 | Preserve | pruned for clearance, MPE, GR, mechanical damage on large root adjacent to curb |
