Photo Survey of 1111 N. Indian Hill Boulevard

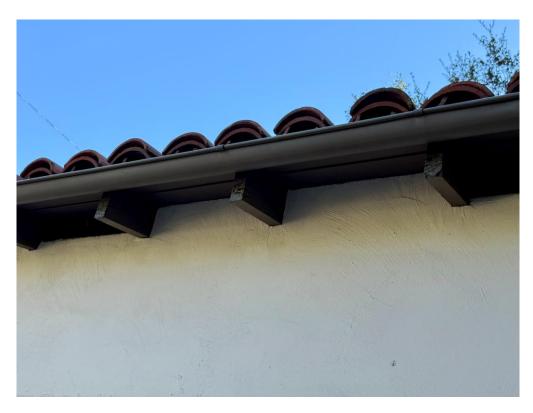
Two-piece clay tile roof. Damage to wooden rafters.

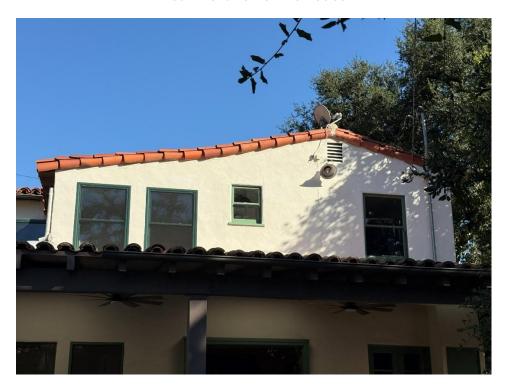
Close up of second-story windows. The two windows to the right are original windows. The two on the left have been altered, but are included in the applicant's Ten Year Plan to be restored to historic character.

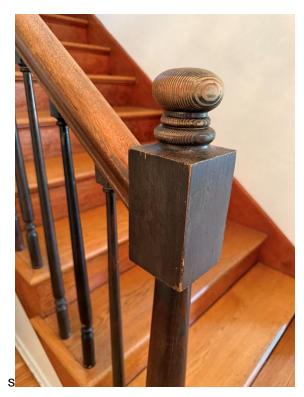
Historic staircase that does not meet current code for height of railing.
