Re: Tree Inventory and Impact Report – Amendment Letter, Revised 10.23.25

Roberts East Campus Sports Bowl, Claremont McKenna College, Claremont, California

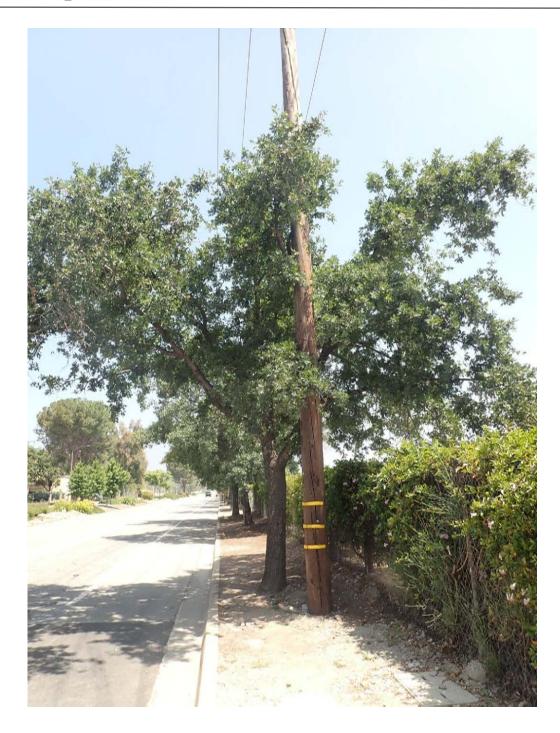
- Tree ST1
- Quercus lobata
- Arborist's opinion Planted
- Facing northwest

Construction of the south parking lot driveway, new streetlights, and fire hydrants will result in removal of structural and absorptive roots that will compromise the health and structural integrity of the trees proposed for removal along the east side of Claremont Boulevard. The proposed driveways on the will require the removal of trees numbered ST8, ST9, and ST25. Placement of new fire hydrants will require the removal of trees numbered

ST1, ST7, ST16, ST29 and ST58. New streetlights will require the removal of trees numbered ST22, ST30, ST32, ST36 and ST61.

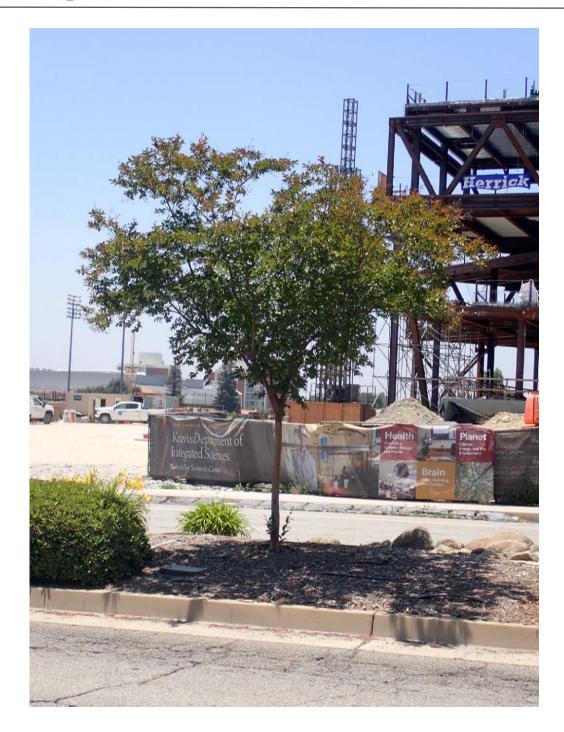
- Tree ST63
- Lagerstroemia indica
- Arborist's opinion Planted
- Facing west

| Street Tree (ST)/Private Property Tree (PP) | Tree ID # | Common Name | Botanical Name | DBH (in.) | CRZ 3' (Ft.) | CRZ 5' (Ft.) | Height (Ft.) | Canopy N (Ft.) | Canopy E (Ft.) | Canopy S (Ft.) | Canopy W (Ft.) | Health Grade | Structure Grade | ST Tree Trunk (center) Distance to Curb Face (in inches) | Tree Disposition (Preserve or Remove) | Comments |
|--|---|---|---|---|---|---|---|---|---|---|---|---|---|--|---|--|
| ST | 63 | crape myrtle | Lagerstroemia indica | 2.2 | 0.6 | 0.9 | 10 | 6 | 6 | 6 | 6 | А | В | | Preserve | should be replaced due to mechanical damage, in center median |

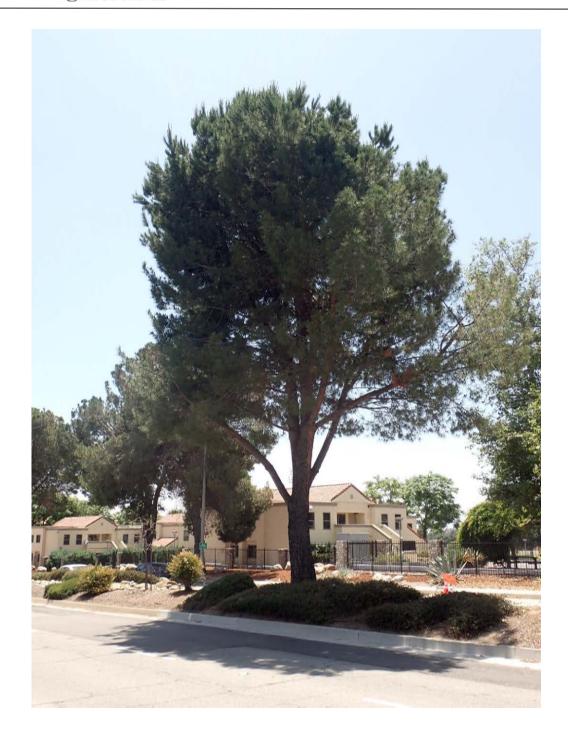
- Tree ST70
- Eucalyptus sideroxylon
- Arborist's opinion Planted
- Facing west

Construction of the turn pocket in the median north of E. 9th Street will require removal of street trees numbered ST97 and ST98, and construction of the tunnel under Claremont Boulevard south of E. 9th Street will likely require removal of median trees number ST69 and ST70, and east side street tree number ST17.

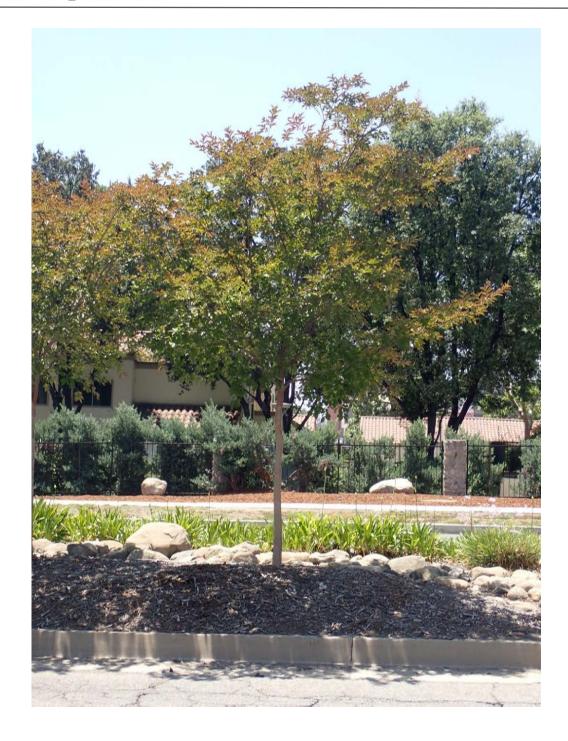
- Tree ST88
- Lagerstroemia indica
- Arborist's opinion Planted
- Facing west

| Street Tree (ST)/Private Property Tree (PP) | Tree ID # | Common Name | Botanical Name | DBH (in.) | CRZ 3' (Ft.) | CRZ 5' (Ft.) | Height (Ft.) | Canopy N (Ft.) | Canopy E (Ft.) | Canopy S (Ft.) | Canopy W (Ft.) | Health Grade | Structure Grade | ST Tree Trunk (center) Distance to Curb Face (in inches) | Tree Disposition (Preserve or Remove) | Comments |
|--|---|---|---|---|---|---|---|---|---|---|---|---|---|--|---|---|
| ST | 88 | crape myrtle | Lagerstroemia indica | 2.4 | 0.6 | 1 | 11 | 6 | 8 | 7 | 6 | A- | В | | Preserve | in center median, mechanical damage on S with good callous |

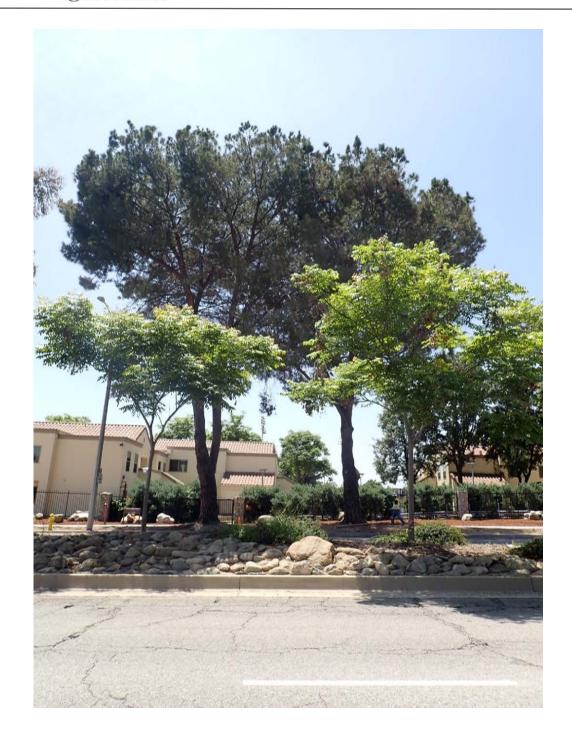
- Tree ST92
- Pinus pinea
- Arborist's opinion Planted
- Facing west

The stone pines on the west side of Claremont Blvd. (ST92-ST96) are proposed for removal not due to construction/street improvements, but for replacement with new trees in the renovated parkway that will be consistent with the parkway landscaping palette on the east side of the street. These five stone pines are remnants of the parkway row of about a dozen stone pines that were impacted by the January 21, 2022 windstorm.

Removal of five street trees numbered ST92, ST93, ST94, ST95, and ST96 on the west side of Claremont Boulevard is proposed due to sidewalk and parkway renovations, as well as curb and gutter repairs and street renovations that will add a protected bike lane to the west side of the street. Installation of the protected bike lane will include the addition of a landscaped median in the street that will separate cars from cyclists. The existing asphalt will be removed and regraded along the west side of Claremont Boulevard to fix any buckling pavement and to accommodate the bike lane and the new median. Demolition and reconstruction of the curb, gutter, and street, plus parkway and sidewalk demolition and improvements will result in removal of structural and absorptive roots on all four sides of the trunks that will compromise the health and structural integrity of these five Aleppo pines. These five trees are remnants of the approximately a dozen parkway trees that once existed in that stretch of parkway between E. 9th Street and E. 6th Street. The other Aleppo pines uprooted or suffered catastrophic branch/trunk failures in the windstorm of January 2022 and were removed by the City of Claremont. As remnant trees that are no longer partially protected from high winds by the other trees that once stood beside them, cutting and damaging roots on all four sides of their trunks would not only severely impact their health, but it would also significantly increase their risk for future windthrow failure.
