October 23, 2025

**Re: Tree Inventory and Impact Report – Amendment Letter, Revised 10.23.25  
Roberts East Campus Sports Bowl, Claremont McKenna College, Claremont, California**

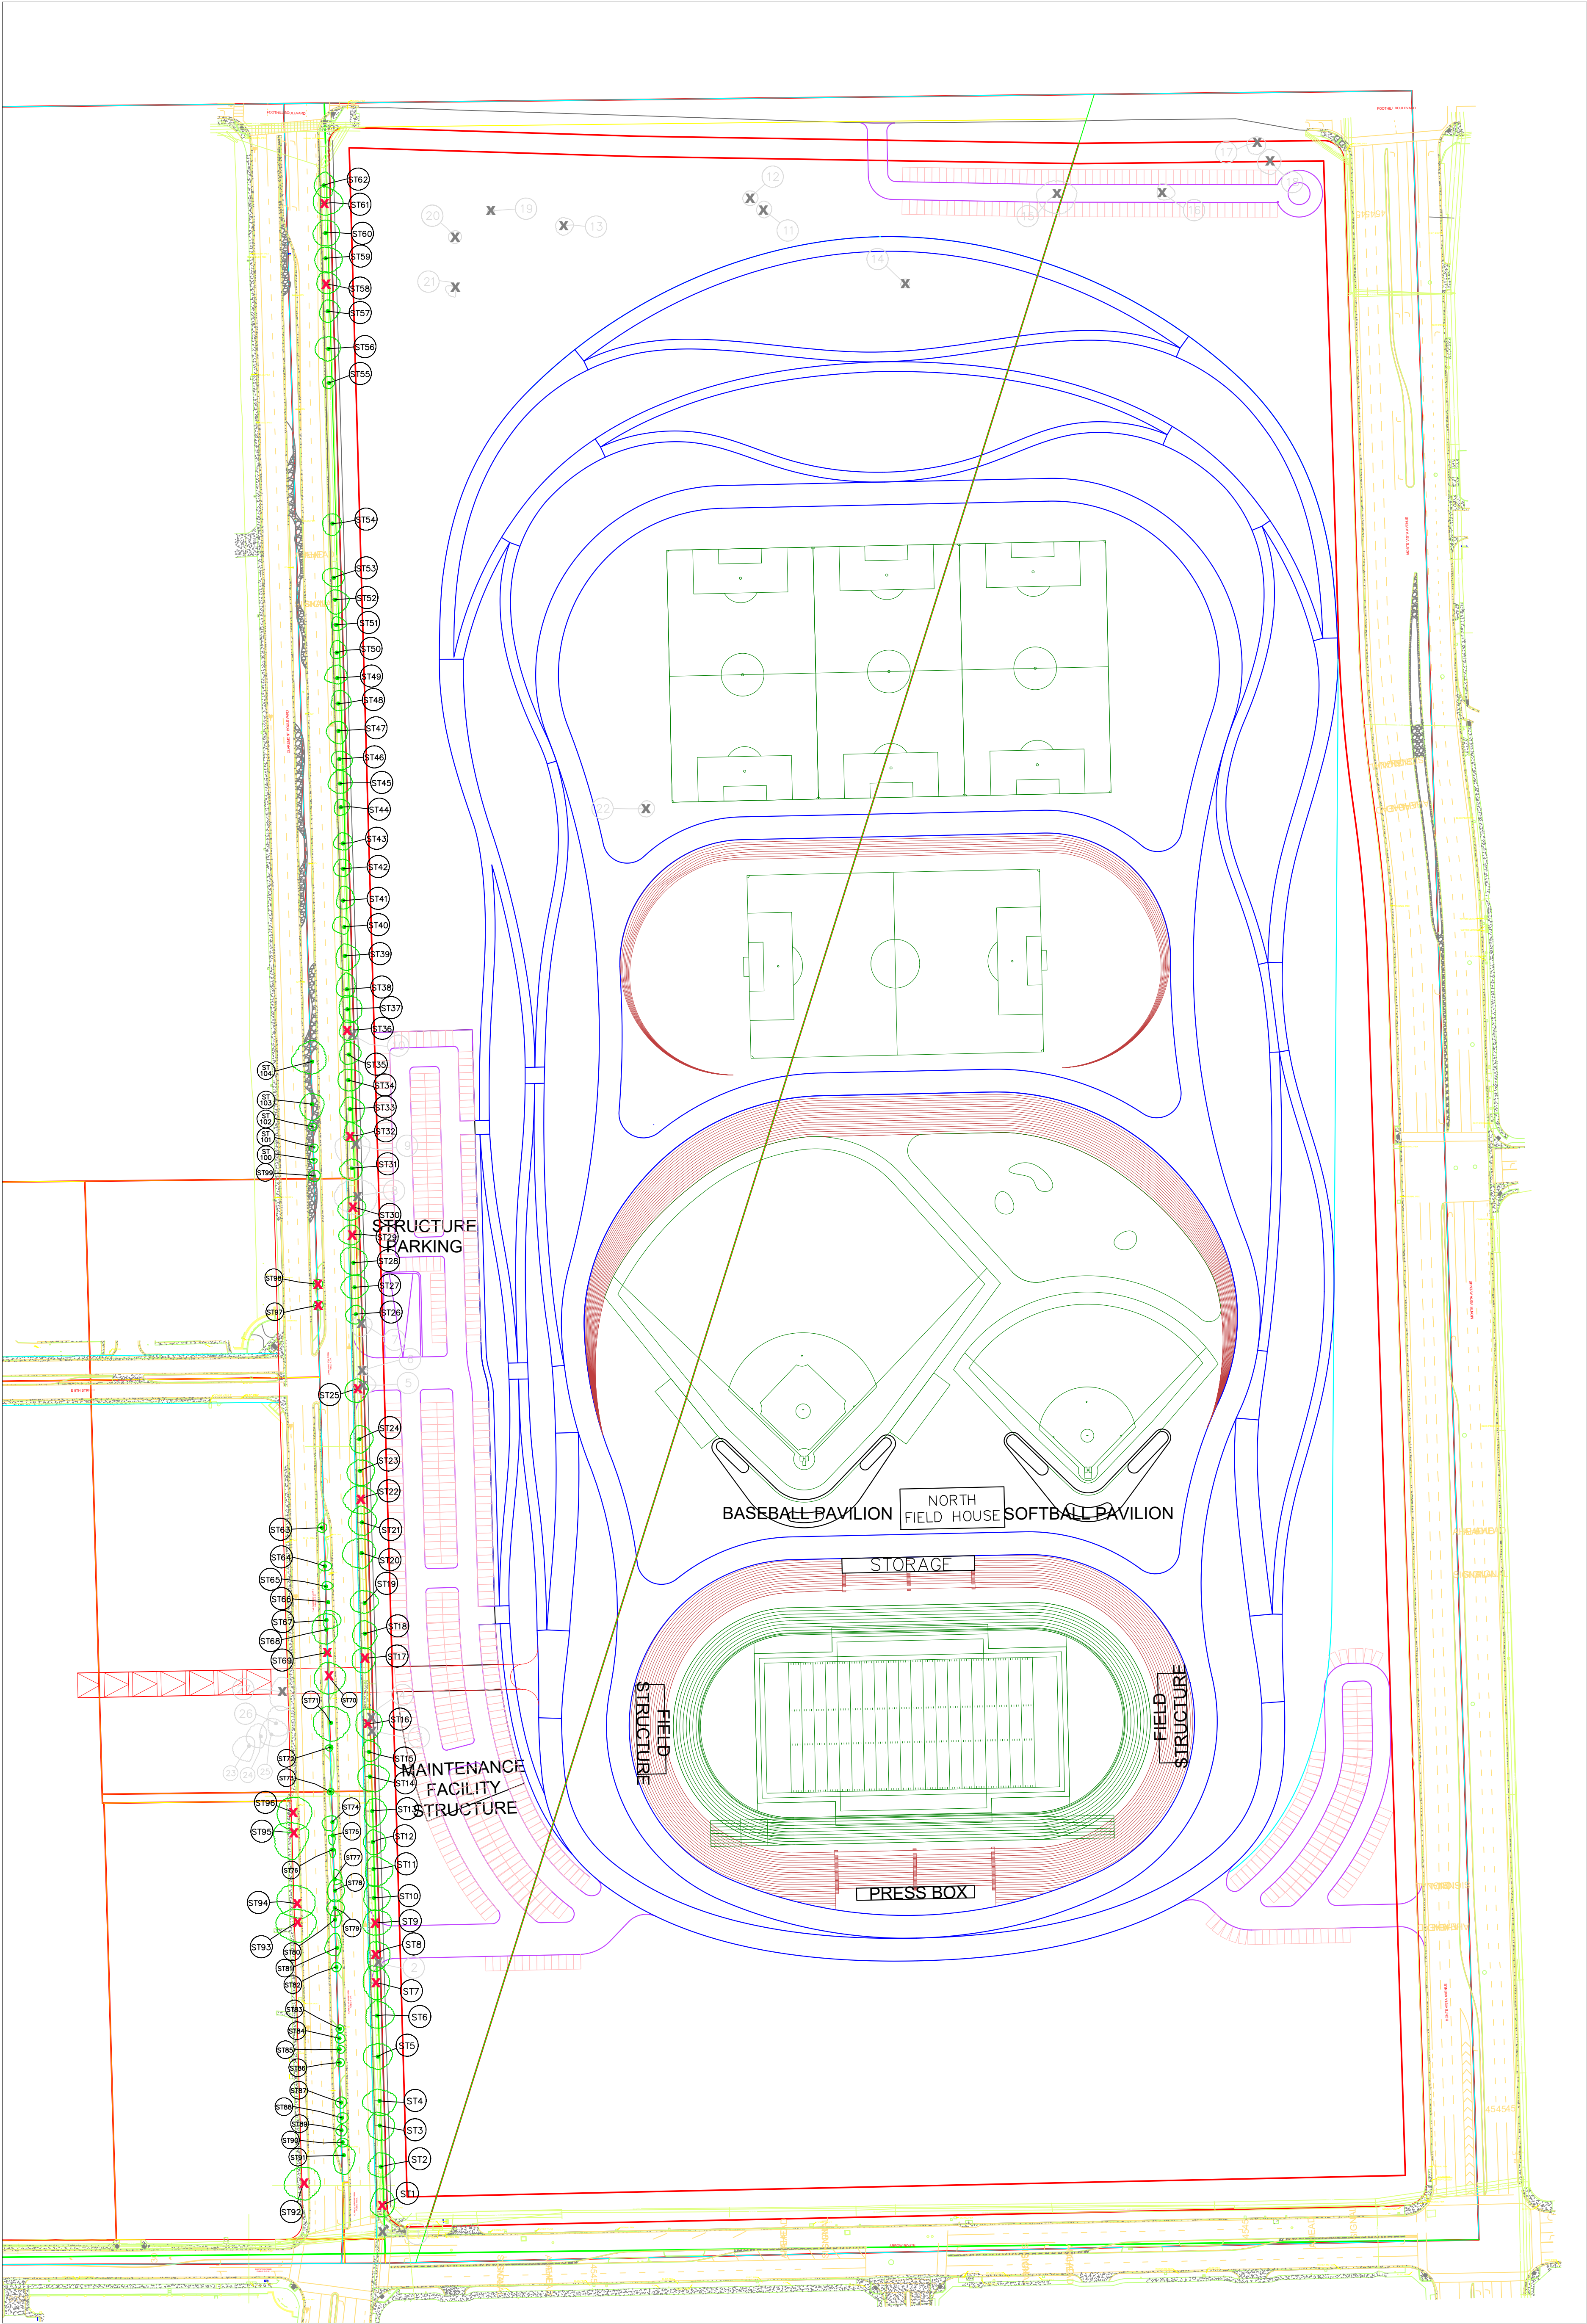
NOTES: LOCATIONS OF INTERIOR TREES #1-22 ARE APPROXIMATE AND ARE NOT PROFESSIONALLY SURVEYED.

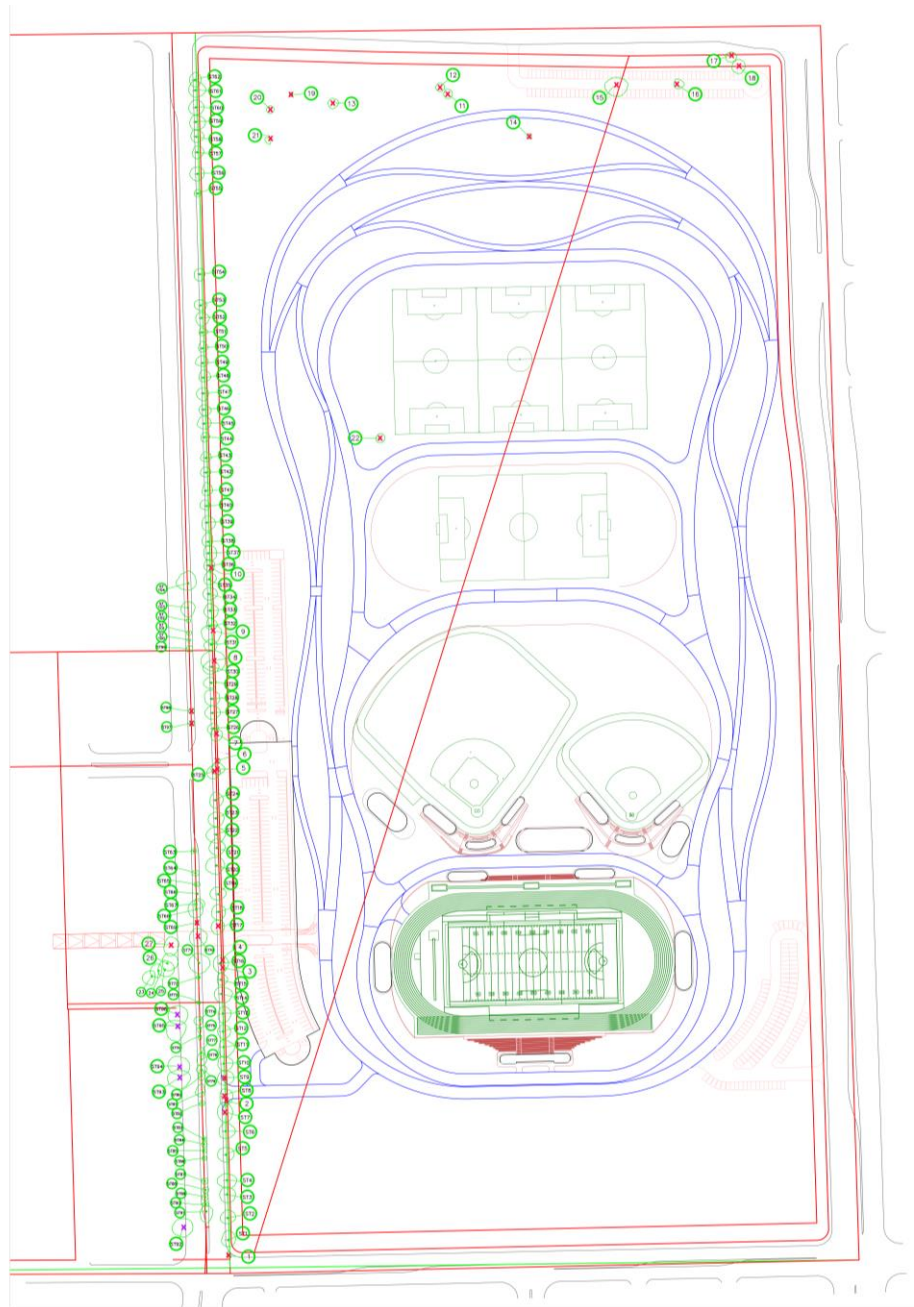
**EXHIBIT B – REDUCED COPY OF THE TREE IMPACT EXHIBIT  
(NOT TO SCALE)**

The stone pines on the west side of Claremont Blvd. (ST92-ST96) are proposed for removal not due to construction/street improvements, but for replacement with new trees in the renovated parkway that will be consistent with the parkway landscaping palette on the east side of the street. These five stone pines are remnants of the parkway row of about a dozen stone pines that were impacted by the January 21, 2022 windstorm.

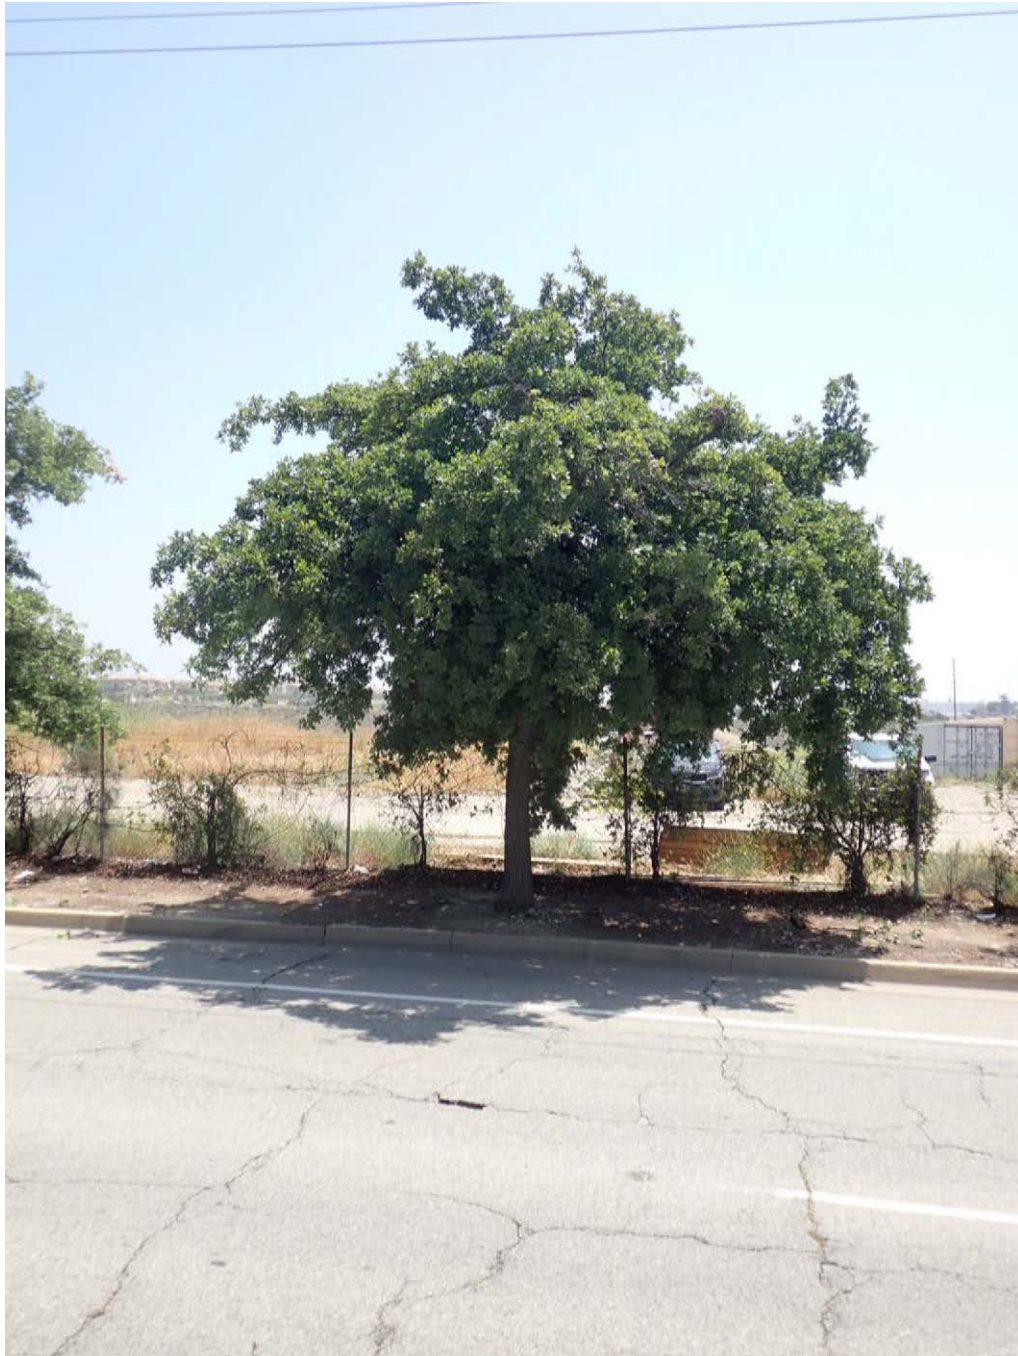
- Tree ST11
- *Quercus lobata*
- Arborist's opinion - Planted
- Facing east

| Street<br>Tree /<br>ST | Tree<br>ID<br>No. | Common Name | Botanical Name | DSH /<br>DBH (in.) | Height<br>(Ft.) | Canopy<br>N (Ft.) | Canopy<br>E (Ft.) | Canopy<br>S (Ft.) | Canopy<br>W (Ft.) | Health<br>Grade | Structure<br>Grade | Disposition<br>(Preserve,<br>Remove) | Reason for Removal | Comments | 3X Critical<br>Root Zone<br>(in feet)* | 5X Critical<br>Root Zone<br>(in feet)* | ST Tree<br>Trunk<br>(center)<br>Distance to<br>Curb Face<br>(In.) |
|---|---|---|---|---|---|---|---|---|---|---|---|---|---|---|---|---|---|
| ST | 11 | valley oak | <i>Quercus lobata</i> | 13.9 | 24 | 15 | 24 | 22 | 10 | B+ | B- | Preserve | | pruned for clearance, MPE, GR,<br>mechanical damage on large root<br>adjacent to curb | 3.5 | 5.8 | 42 |

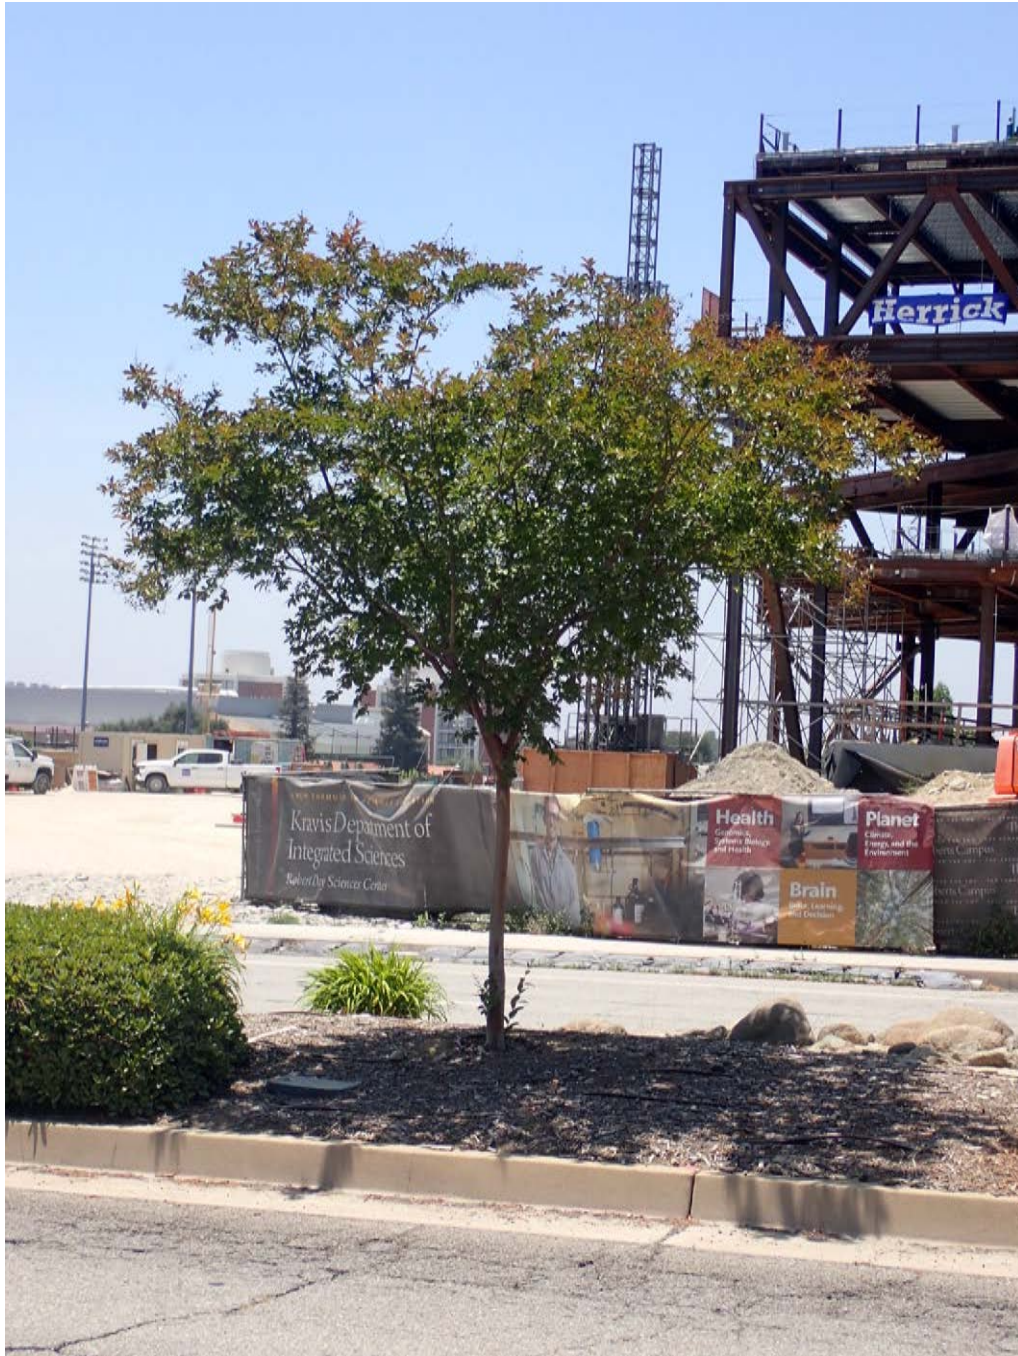
- Tree ST63
- *Lagerstroemia indica*
- Arborist's opinion - Planted
- Facing west

| Street Tree / ST | Tree ID No. | Common Name | Botanical Name | DSH / DBH (in.) | Height (Ft.) | Canopy N (Ft.) | Canopy E (Ft.) | Canopy S (Ft.) | Canopy W (Ft.) | Health Grade | Structure Grade | Disposition (Preserve, Remove) | Reason for Removal | Comments | 3X Critical Root Zone (in feet)* | 5X Critical Root Zone (in feet)* | ST Tree Trunk (center) Distance to Curb Face (In.) |
|---|---|---|---|---|---|---|---|---|---|---|---|---|---|---|---|---|---|
| ST | 63 | crape myrtle | <i>Lagerstroemia indica</i> | 2.2 | 10 | 6 | 6 | 6 | 6 | A | B | Preserve | | staked, stakes should be replaced due to mechanical damage, in center median | 0.6 | 0.9 | |

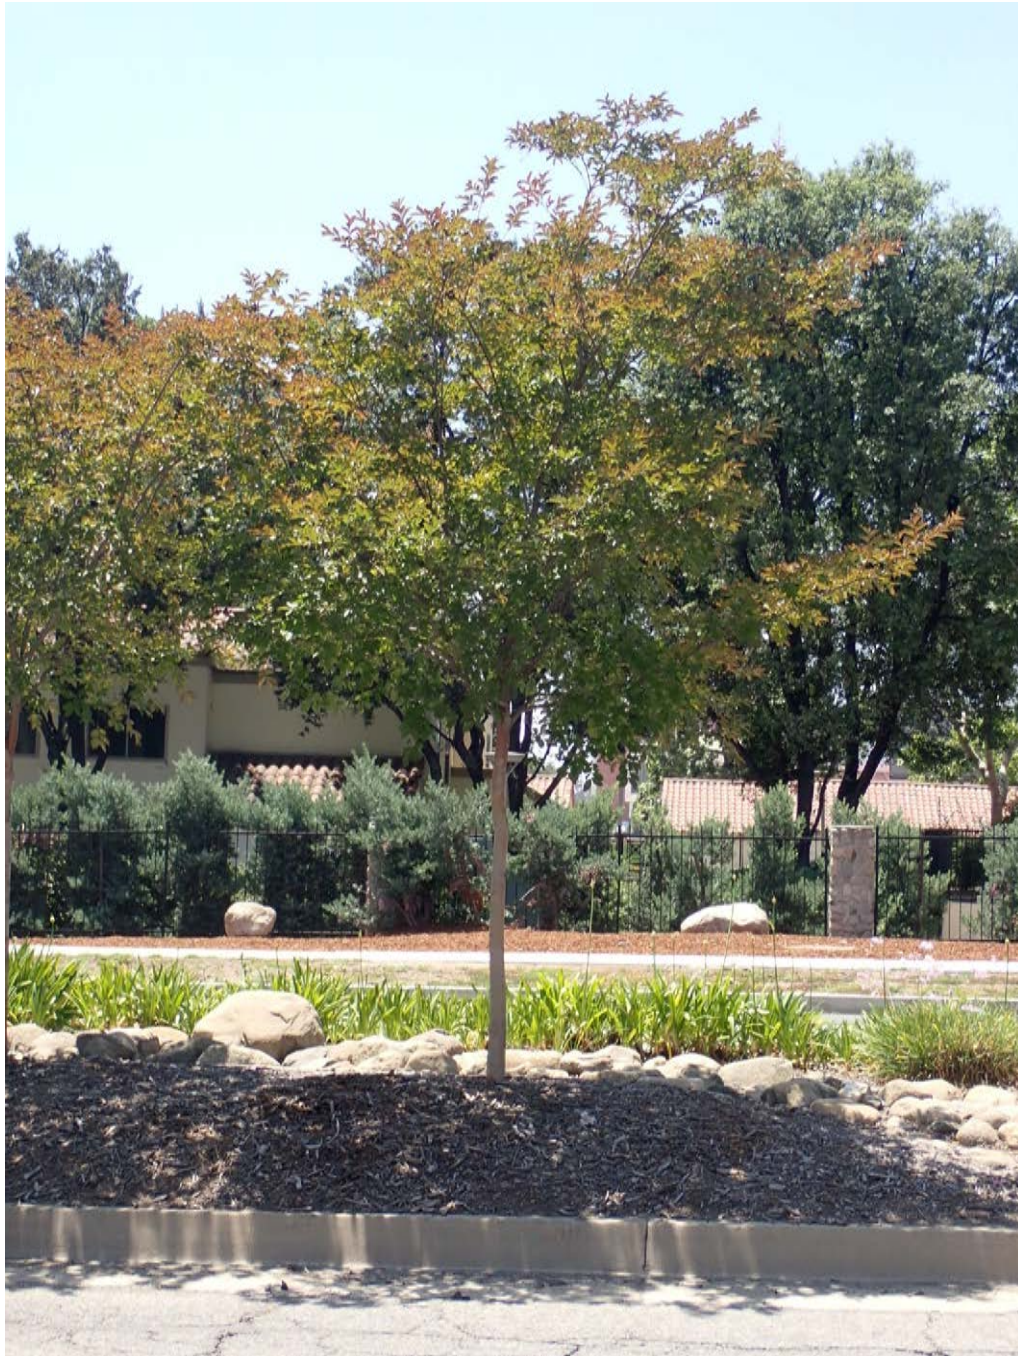
- Tree ST88
- *Lagerstroemia indica*
- Arborist's opinion - Planted
- Facing west

| Street Tree / ST | Tree ID No. | Common Name | Botanical Name | DSH / DBH (in.) | Height (Ft.) | Canopy N (Ft.) | Canopy E (Ft.) | Canopy S (Ft.) | Canopy W (Ft.) | Health Grade | Structure Grade | Disposition (Preserve, Remove) | Reason for Removal | Comments | 3X Critical Root Zone (in feet)* | 5X Critical Root Zone (in feet)* | ST Tree Trunk (center) Distance to Curb Face (In.) |
|---|---|---|---|---|---|---|---|---|---|---|---|---|---|---|---|---|---|
| ST | 88 | crape myrtle | <i>Lagerstroemia indica</i> | 2.4 | 11 | 6 | 8 | 7 | 6 | A- | B | Preserve | | in center median, mechanical damage on S with good callous | 0.6 | 1 | |
