Re: Tree Inventory and Impact Report – Amendment Letter, Revised 10.23.25

Roberts East Campus Sports Bowl, Claremont McKenna College, Claremont, California

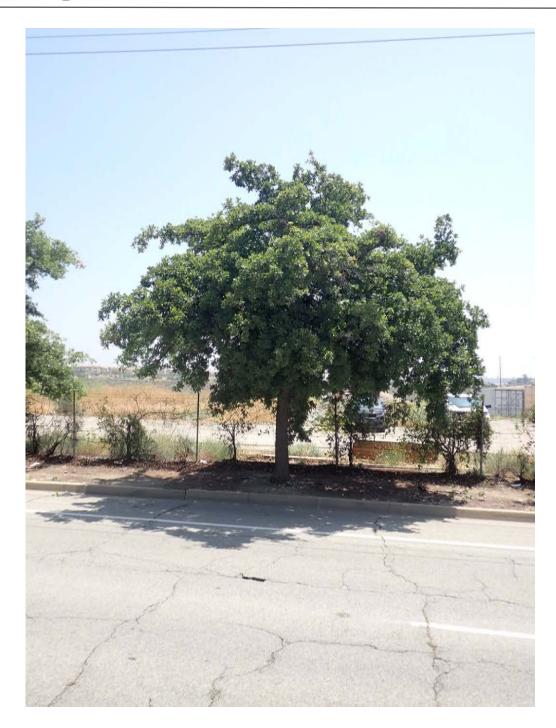
- Tree ST11
- Quercus lobata
- Arborist's opinion Planted
- Facing east

| Street Tree / ST | Tree ID No. | Common Name | Botanical Name | DSH / DBH (in.) | Height (Ft.) | Canopy N (Ft.) | Canopy E (Ft.) | Canopy S (Ft.) | Canopy W (Ft.) | Health Grade | Structure Grade | Disposition (Preserve, Remove) | Reason for Removal | Comments | 3X Critical Root Zone (in feet)* | 5X Critical Root Zone (in feet)* | ST Tree Trunk (center) Distance to Curb Face (In.) |
|---|---|---|---|---|---|---|---|---|---|---|---|---|---|---|--|--|---|
| ST | 11 | valley oak | Quercus lobata | 13.9 | 24 | 15 | 24 | 22 | 10 | B+ | B- | Preserve | | pruned for clearance, MPE, GR, mechanical damage on large root adjacent to curb | 3.5 | 5.8 | 42 |
