425 W 10th

Mill's Act Photo Survey

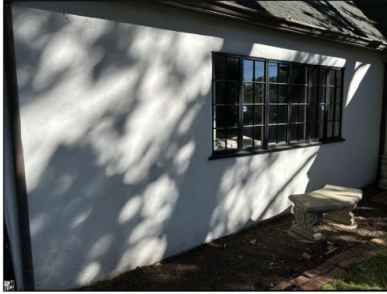
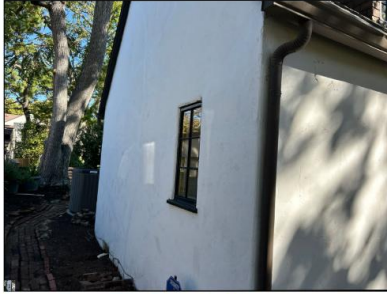
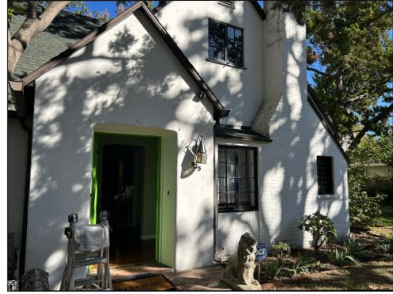
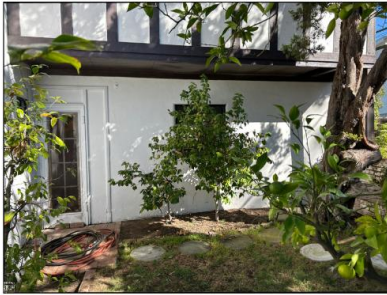
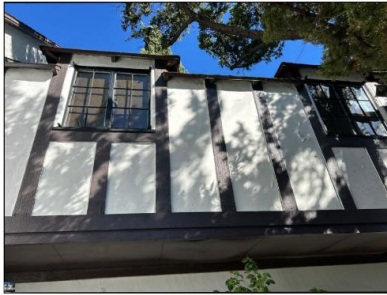
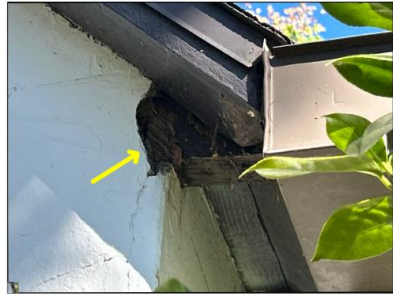
Cracking/chipping/holes more than typical - needs to be serviced

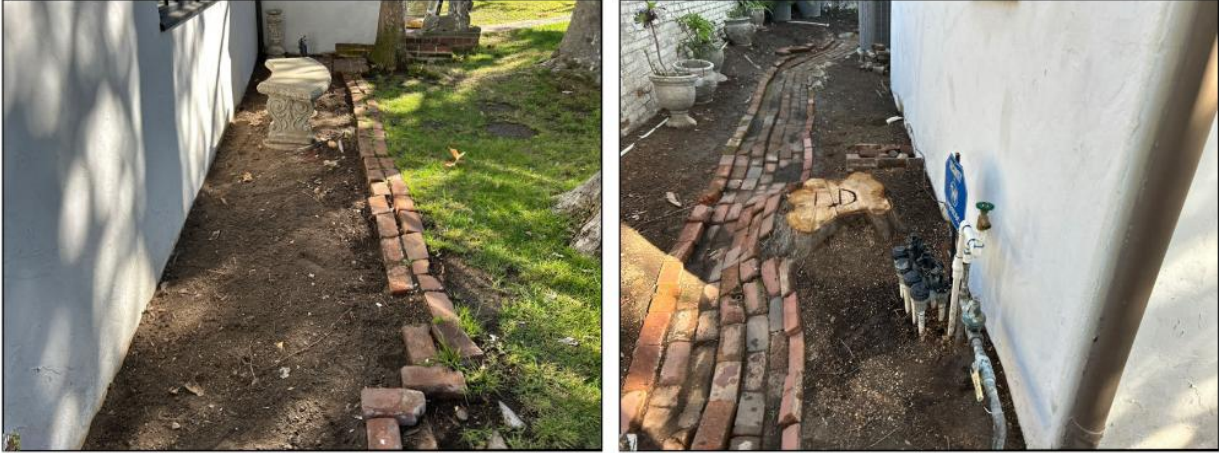
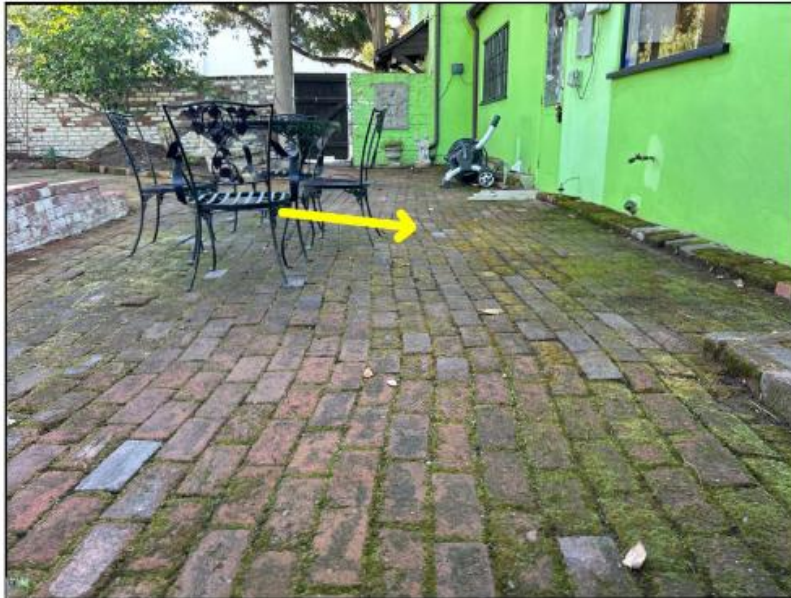
Grade slopes towards structure - needs to be serviced

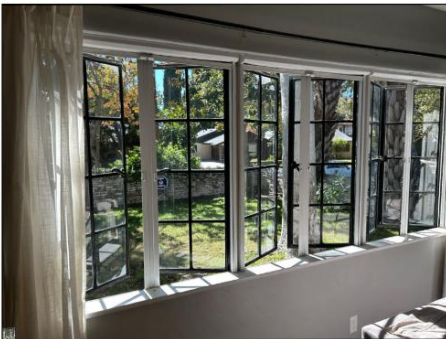
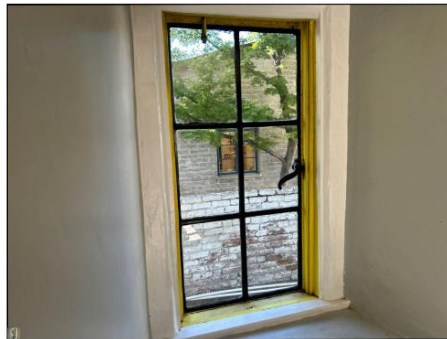
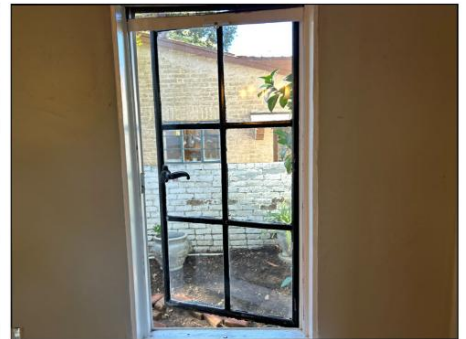
Cracked glass- needs to be serviced. Master bathroom.

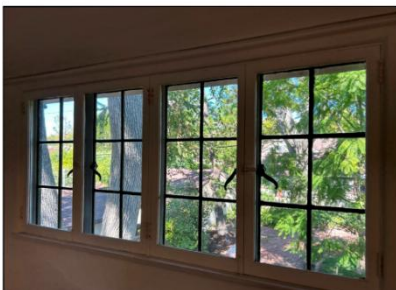
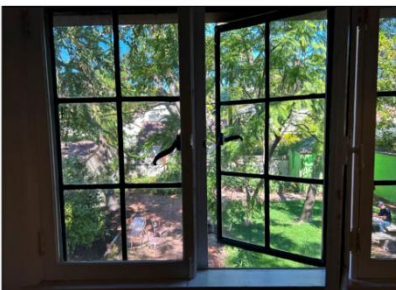
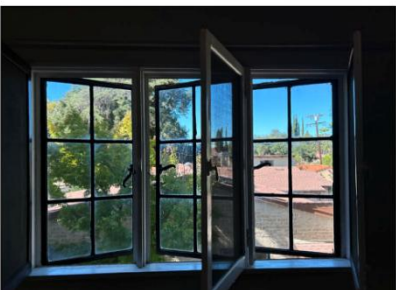
Cracked glass - needs to be serviced

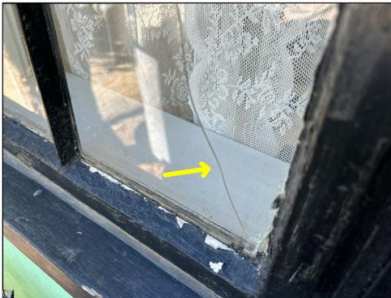
Cracked glass - needs to be serviced
